Mechanism of cracks and rehabilitation schemes of some Arch Dam

Abstract: Some Arch Dam has been in operation for more than 20 years, and many cracks have occurred in the dam body. After several times patches processing, the cracks still have the tendency of development, which have seriously affected the overall safety of the dam. In order to analyze the cracking mechanism and to study the feasibility of rehabilitation schemes, the stress and the deformation laws of the dam body and foundation under different loads are analyzed by use of 3D FEM. The active status of the arch dam under the design condition is simulated by the actual increase load process. In addition, the mechanism of cracks is analyzed, and a reinforcement scheme is proposed, in which the upstream surface spurts the thermal insulation materials and the downriver surface hangs spurts the steel textile fiber concrete. In order to determine the rationality of the rehabilitation scheme, 3D temperature fields of the dam are calculated, which provides the loads for the 3D stress field analysis. Then the stress and the deformation laws of the dam body under different operating modes are calculated, with the 3D finite ele

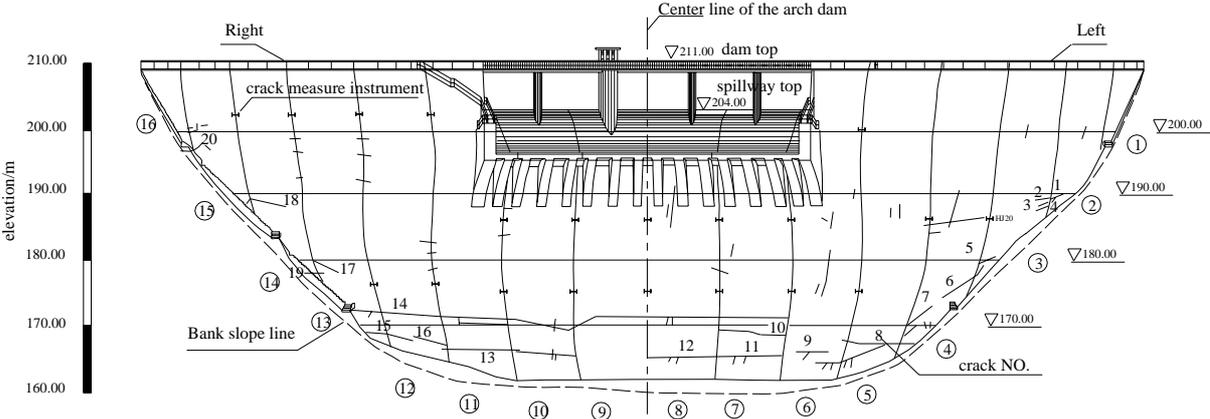
downstream dam faces of the left and right banks, respectively, and in 1986 grouting treatment was performed. Distribution of cracks is shown in Fig. 1. Crack Nos. 1~20 occurred during 1979~1986, among which, 12 cracks were caused in the downstream in winter of 1978; the cracks without number were developed during 1986~2001. Bleeding phenomenon of water and dissociative calcium occurred at the cracks. These cracks not only had an effect on dam view and leakage, but also on dam strength and safety. It is necessary to analyze their causes for generation and development. And on such a basis, crack rehabilitation schemes are to be studied.

Fig. 1 Positions of cracks of downstream surface of the Arch Dam

After the grouting, the dam was in a state of normal operation. From the observed data during 1986 ~ 1994, the width of the cracks at the left bank of the downstream dam face had a tendency of increase. However, no new cracks were found, and the grouted cracks did not become larger. After 1996, new cracks continuously occurred in the downstream dam face, and the leakage points increased. Till the end of 2001, over 40 points were discovered, and white separated compounds were accompanied. Some intersections between the cracks and horizontal joints leaked, and the seepage section was long, resulting in new cracks. Inspection on Dec. 14, 2001 shows that 6 horizontal or oblique cracks occurred at No. 6, No. 8, No. 10 and No. 11 blocks, and the total length was 28.1 m. Through the detections by use of ultrasonic waves respectively by Nanjing Hydraulic Research Institute and Anhui Provincial Hydraulic Research Institute in 1979 and 1986, the maximum depths of cracks were 2.3 m and 2.14 m, respectively, the width of cracks was not larger than 1.0 mm; at the beginning of 2002, through the detection of new and old cracks by Huaihe River Basin Hydraulic Engineering Quality Inspection Center, the width of cracks was 0.05~0.45 mm. From the above detection results, the cracks at the downstream face of the Arch Dam are all surface cracks.

Generally, owing to the restriction of types and direction of the Arch Dam, cracks will surely occur under the condition of empty reservoir and temperature rising. The actual operation is that the cracks at the left and right banks observed on Aug. 26, 1978 are resulted from the above causes. Owing to the restriction of upper arch rings, the deformation of bank slop girders towards the upstream is restricted, thus the tensile cracks did not extend towards the deep part of the dam. From the above, the cracks appeared at the later period in the downstream dam face are surface ones mostly caused by nonlinear temperature difference of dam faces.

The rehabilitation work of the Arch Dam began in Oct. 2004 and completed in Dec. 2005^[5]. At first, steel fiber concrete materials are employed for dam reinforcement. In order to ensure the engineering quality, the employed steel fibers are the shear pattern with claws on both ends. According to different strength requirements of different reinforcement parts, the steel fibers with different dimensions are employed, it is 0.5 ~ 1.0 m in thickness from the dam crest to the dam bottom. As for the outer surface above the elevation of 183.0 m in the upstream and downstream of the dam, polyaminoester urethane foam (PUF) 5 cm in thickness is employed as the heat insulating materials. After about 5 s when the PUF is placed on the surface of structures, polyaminoester foam heat insulating layer is formed. Its coefficient of heat conductivity is only 1.3% of that of the concrete. Good heat insulating materials will obviously reduce temperature stress of the dam.
