Analysis of the One Reservoir Dam Breach Cause and the Repair Design

Abstract: The right vice-dam of the One Reservoir in Qinghai Province breached on the morning of April 28th, 2005. In order to thoroughly investigate the cause of the dam breach and collect data for the coming reconstruction, analyses are made on the non-uniformity deformation, seepage characteristic, anti-sliding stability under the circumstance of earthquake, based on the original design and construction data of the dam. Conclusion is that the cracks between the bottom and two sides of the spillway and the dam body, and the subsequent seepage compounded by the earthquake, are the main factors behind the dam breach. Based on the above analyses, the repair design of the breached dam section is presented, including the selection of the repair plan of spillway based on topography and geological research and the plan of the repair of the collapsed dam section and the reconstruction the spillway.

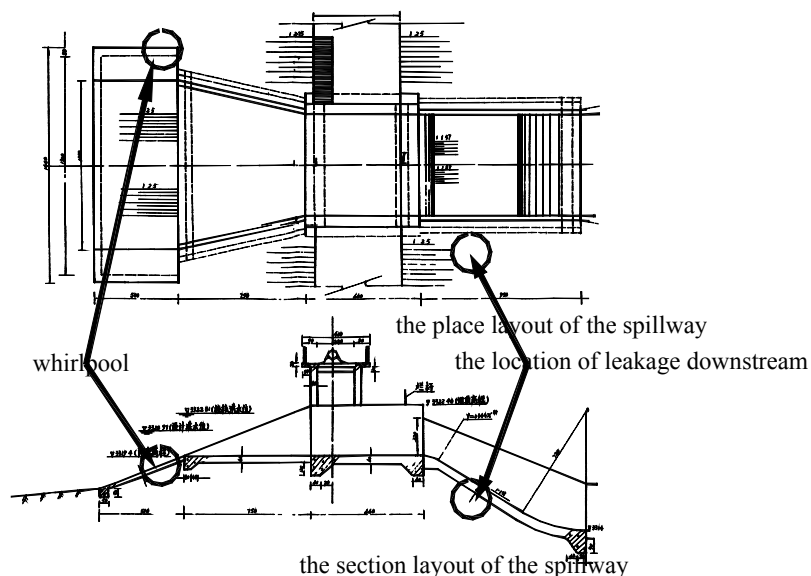
The spillway was normal till 1 o'clock April 28th. At 3:30 a water flow, with a diameter of 20cm, was detected on the right slope of the spillway lower reaches, and the elevation of the seepage spot was about 3317.80m. So the reservoir workers opened the spillway gate to let water

out, even so, the seepage water's diameter increased to 60cm within 5-6minutes. And whirlpool with about 3318.80m elevation was detected in the left upper reaches of the spillway (see fig.2). At 4:40 the lower reaches of the spillway began to collapse, and at about 5:40 a scouring cut off 3m size appeared on the right side of the spillway top. Seepage water gained momentum and the dam body below the spillway was emptied by the scouring water. At about 6:20 the whole right spillway was breached, with its scouring cut more than 20m wide.

Fig.2 The location of the seepage spot and the whirlpool

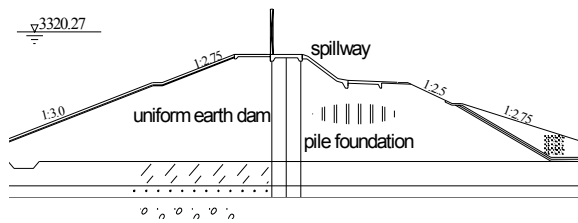
Figure 3 Spillway section

Seen from the section layout of the former spillway (see fig.3), nine concrete piles formed the pile foundation of the spillway bottom, based on the sand-gravel stratum. A conclusion can be made that pile load is mainly the function of pile friction according to the design and layout of the piles. So the piles are friction end-bearing piles. The load from the bottom surface above was all on the end-bearing piles and finally transferred to the hard sub-rock layer or sub-soil layer, and a dislocation appeared between the spillway bottom and the contact surface of base earth. The dislocation eventually led to contact flushing. On-the-spot inspection discovered that level cracks first appeared between the junction of the gate bottom and the dam body. Because the gate bottom was of rigid structure and the dam body was of uniform earth, flexible structure, and the uncoordinated deformation between the rigid structure and flexible structure first led to level cracks(see fig.4). Meanwhile, the connection between the gate bottom and the two wing walls was rigid. When the gate bottom was jacked by reinforced piles, uncoordinated deformation between the junction of the wing walls and the dam body made the settlement of wing walls smaller than that of the base earth. So vertical cracks appeared on the sides of the gate bottom. When influenced by outside forces, cracks develop on the contact surface. And the earthquake compounded the cracks or the dislocation between the spillway and the dam body, finally created seepage tunnel.

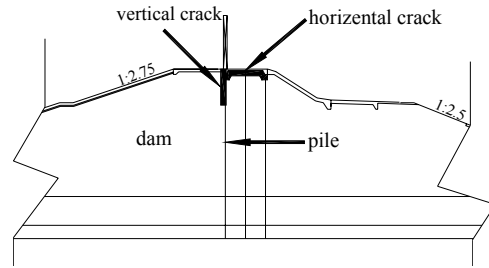
Seen from the section layout of the former spillway, the spillway on the dam body was of rigid structure, or reinforced concrete structure; the dam body below the spillway was of flexible structure. So the spillway foundation settlement and the pile foundation settlement consisted of the calculation of settlement. Based on geological survey and through layer wise summation method, a conclusion is drawn that the final settlement of the dam body below the spillway was 0.224m. But the actual settlement of the gate bottom was little because it was jacked by the reinforced piles based on the sand-gravel stratum. So at the gate bottom appeared level cracks and then at the junction of the dam body and the spillway's gate and wing wall also appeared cracks.

Figure 4 The location of cracks

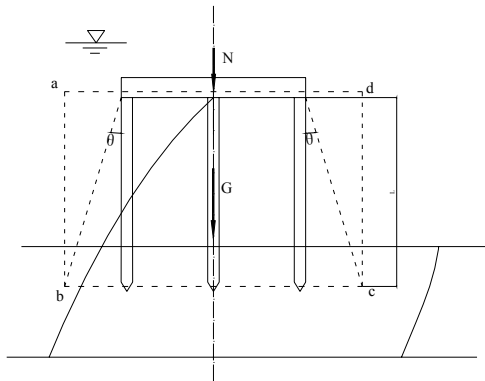
Figure 5 Diagram of the pile foundation

The foundation of the spillway gate bottom is made of 9 reinforced piles. That is, the spillway bottom has a pile foundation. The calculation diagram is illustrated in figure 5. The settlement of the pile foundation is 0.025m through calculation of settlement of the soil in the compacted layer below the pile-end surface, based on even load on rectangular foundation theory. So there was a about 20cm crack between the gate bottom and the dam body below, and that is the location of the seepage contact.

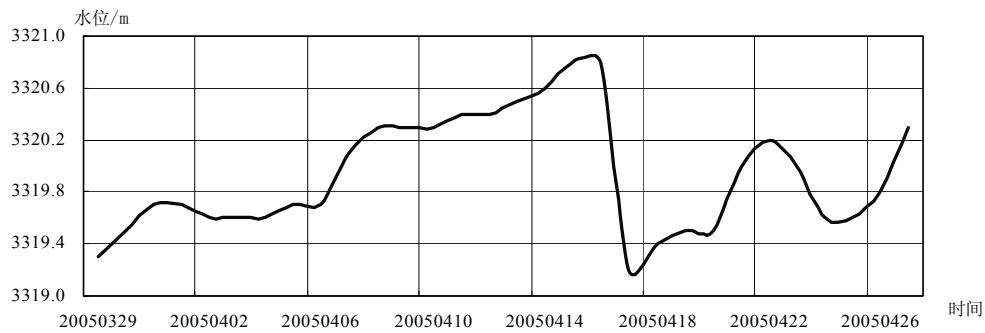
Fig.10 One-month-long water elevation curve before the dam breach

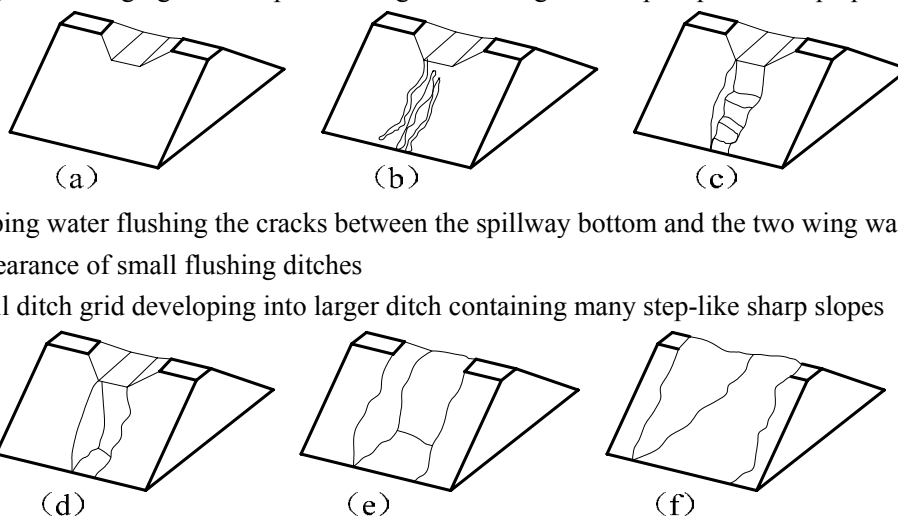
There was long-time water flushing in the cracks between the spillway gate bottom and the two wing walls, meanwhile, overflow from the top flushed the slope in the lower reaches and developed many small ditches. With the continuous flushing, these small ditches formed ditch grid and finally evolved into larger ones. There were many step-like small slope in the ditches (see fig. 11c), and as time went by, these small step-like slope made their way toward the upper reaches and at the same time they became wider and wider, eventually they formed large sharp slopes. (See fig. 11d) The bottom in the lower reaches was partly emptied by the flushing water. Under the influence of the flushing water, these sharp slopes further made their way upward till at last they reached the edge of the dam top. Then they reduced the elevation of the breach part on the top of the dam and the spilling water volume increased violently (see fig. 11e), and finally the spillway was completely breached. (See fig. 11f). The enlargement of the ditches and the development of the sharp slopes toward the upper reaches in the dam breach process are results of water turbulent in the flushing area in the lower reaches and its shear stress. The flushing water was continuously scouring the sharp slope, and finally caused the vertical wall side to lose stability and collapse, thus enlarging the collapsed cutting and making the sharp slopes develop upward.

- (a) seeping water flushing the cracks between the spillway bottom and the two wing walls;
- (b) Appearance of small flushing ditches
- (c) Small ditch grid developing into larger ditch containing many step-like sharp slopes

- (d) Ditch evolving into a huge and upward aggressive sharp slope
- (e) Enlarging of the breached cutting
- (f) Complete breach and the breached cutting reaching its final width

Fig.11 the process of the breach of the spillway of the One Reservoir
