FOZ DO AREIA DAM

1. Introduction

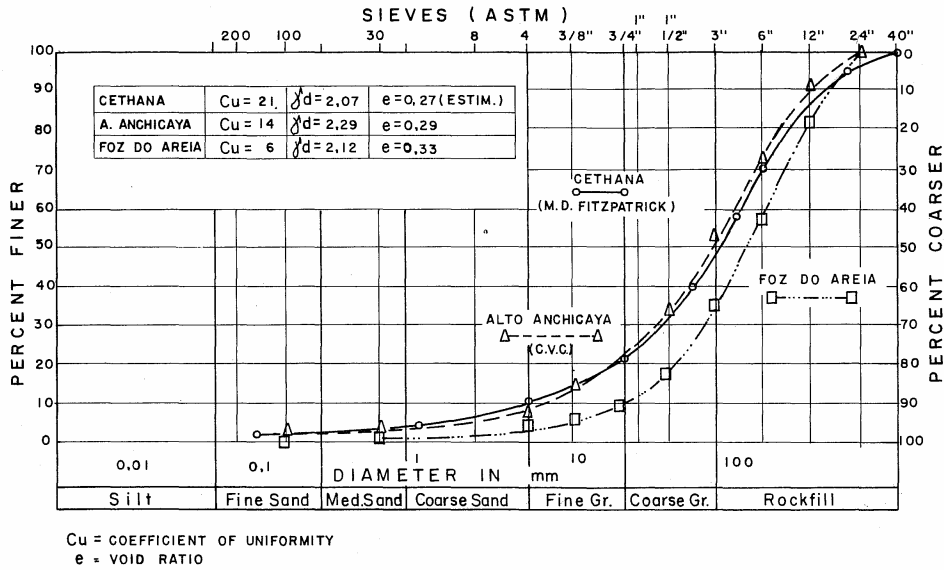
Figure 6. Main Rockfill - Grading Curves

Grading of the rockfill, mostly from structure excavations, proved to be much more uniform than those obtained for other dams. **Figure 6** shows the grading of the Cethana, Alto Anchicaya and Foz do Areia dams. The Foz do Areia void ratio of the rockfill is larger than those from the other two dams.

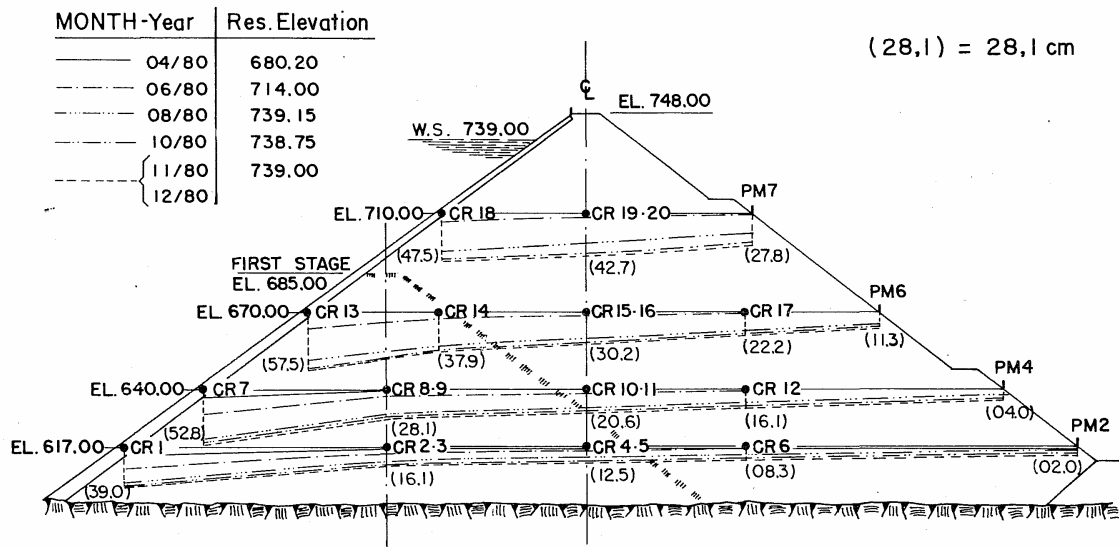
Figure 14. Vertical settlements after reservoir filling

Figure 14 shows the settlement observed in the hydrostatic cells, at the end of 1980, due to reservoir filling only.

Readings taken in September 1981 indicate stabilization of the cells. Maximum settlement at elevation 670 was 59 cm, which is the same reading recorded two months before.

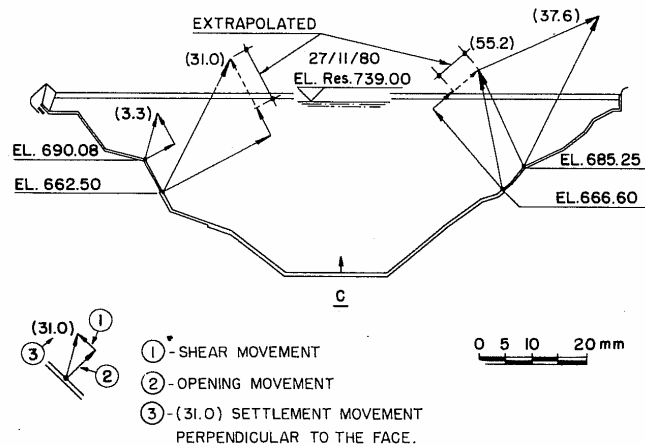
Figure 17. Perimetric joint movements

Maximum shear movement occurred at the right abutment, elev. 685. This value was approximately 29 mm.

Movements perpendicular to the face exceeded 60 mm in two points: one at the right abutment, elev. 666, and the other at elevation 685, at the same abutment. See **Figure 17**.
