# *International Milestone RCC Project*

## *Ralco Dam*

in Chile

<b>Dam type</b>	<b>RCC Gravity Dam</b>
<b>Installed capacity</b>	<b>690WM</b>
<b>Length of dam crest</b>	<b>360m</b>
<b>Height of dam</b>	<b>155m</b>
<b>Dam concrete volume</b>	<b>1.5 million m<sup>3</sup></b>

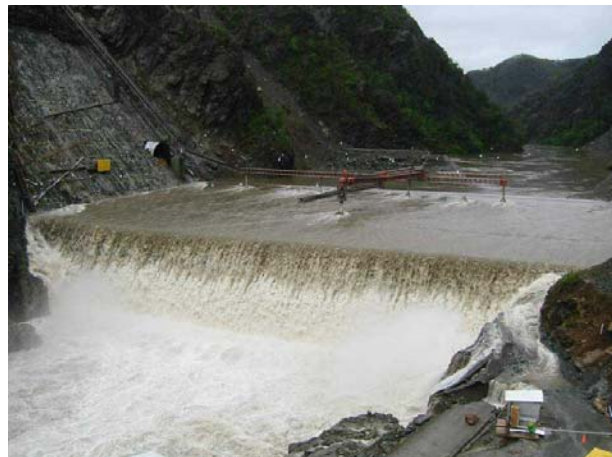
**The second overtopping happened in October 2002**

On both events the dam did not suffer any kind of structural damage, nor was significant the erosion detected on the last lift of RCC placed. The downstream facing steps of the dam did not show any damage despite they worked as a virtual energy dissipator, which proved the good behavior of GE-RCC against eroding action of water.

Due to the high probability of new overtopping occurrences, a lot of actions to avoid damage to the equipment and machinery were adopted, thus protecting the structures, which supported the conveyor belt system throughout the dam. Big rainfall registered during year 2002 implied that river overtopped the dam under construction twice, destroying again downstream cofferdam and access roads to the dam. The first of these overtoppings occurred in August 2002 when the dam was 43 m high, and the maximum flow over the dam reached  $250 \text{ m}^3/\text{s}$ , approximately. The access roads were rapidly recovered, allowing this way to reinitiate the works in a period of only about one week. The second event was produced in October 2002, when the dam was 52 m high, registering  $550 \text{ m}^3/\text{s}$  over it and a water level about one meter over the surface in construction. In this occasion, although the overtopping was doubly important, it did not destroy the accesses, due to the implemented actions, allowing reinitiating immediately the construction works once the Biobío river level decreased.

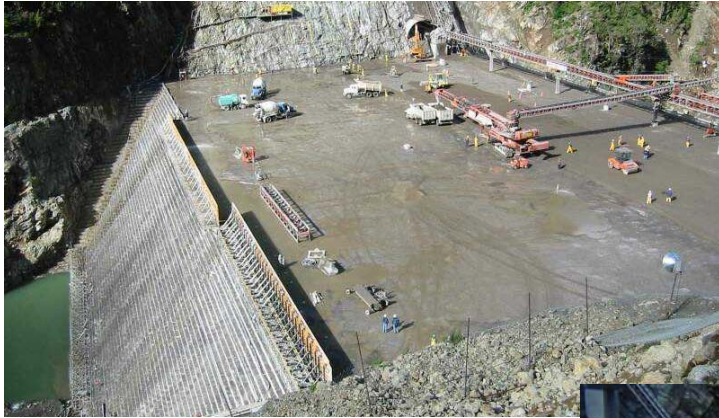
**Re-construction in November 2002**

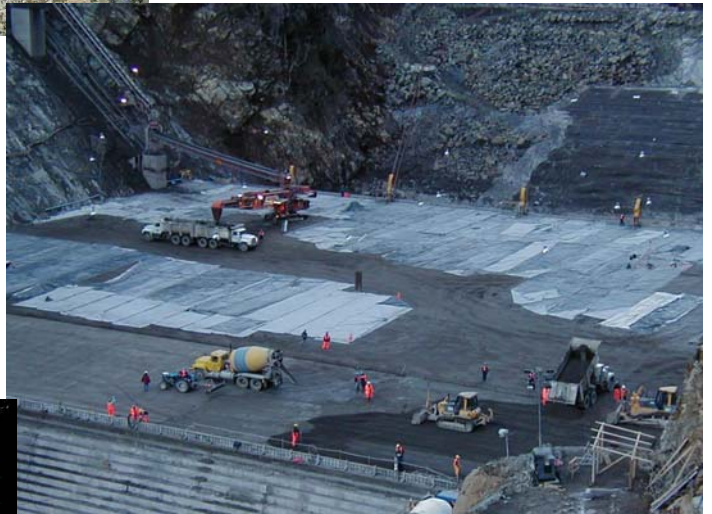
**Protection of RCC exposed surface with thermal blankets**

Under cold weather, heating of mixing water and protection of RCC exposed surface with thermal blankets were considered. On the other hand, when the temperature exceeded 25°C, it was considered to lower the temperature with permanent watering by sprinklers and increasing the workability of RCC produced, so that, due to loss of moisture during transportation, the specified workability for placement (15 seconds Vebe) was accomplished. Under the most extreme weather conditions, the RCC placement

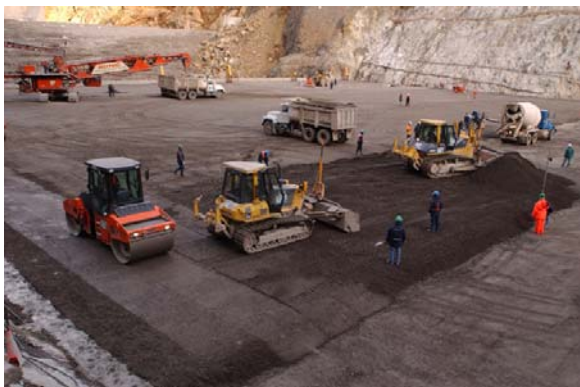
**Bedding mix and Vibrating Rolling**

RCC strength was controlled by means of the nuclear densimeter, so as to have four measurements throughout the surface of the lift being placed. The obtained average density had to exceed the 99% of the air free density of RCC and any point had to be inferior to 98.5%. Otherwise, the complete lift or the area where density was lower than the minimum admissible limited had to be re-compacted. These values were normally obtained with four passes of the double-drum vibrating roller used.
